## CONCRETE COLUMNS

### **DECAY INDICATORS**

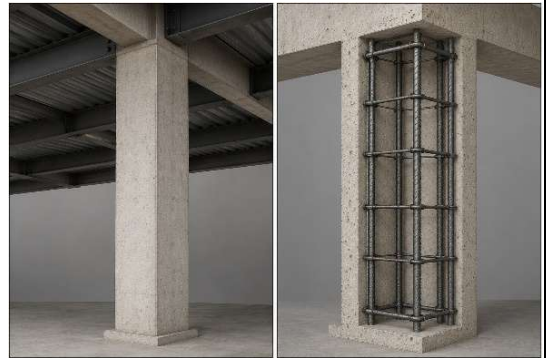
Concrete columns are vertical structural members that transfer concentrated floor, roof, and framing loads downward through the building. Reinforcement is commonly embedded within the concrete but may not be apparent during fireground operations.
